Study on characteristics for steel suspended ceiling with multiple slopes

Department of Production Engineering, Building Research Institute

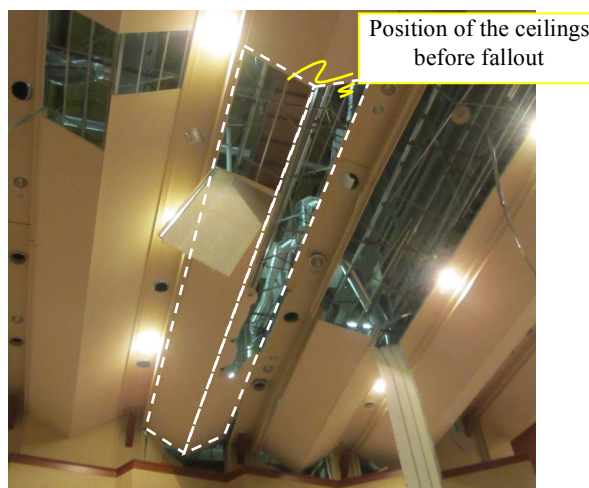
There is another demand for integration. Among the ceilings corresponding to specific ceilings, some ceilings whose surfaces are sloped for acoustic design, such as a hall. As shown in Photo 1, a part of ceiling of the hall is fallen by recent earthquakes, so we need to take countermeasures. However, technical considerations behind the standards are provided mostly based on a horizontal ceiling, and it is not clear whether the similar earthquake resistance method is also applicable to a suspended ceiling with slope.

Photo 1: Earthquake damage on the ceiling of a hall with multiple slopes. (NILIM, et al. 2016)

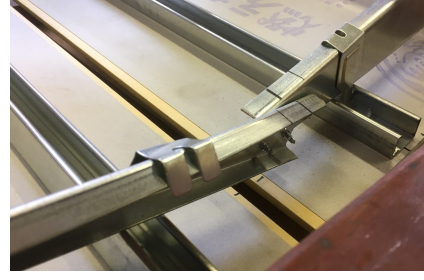
Photo 3: Lateral deformation of C-bar. (No. 6)

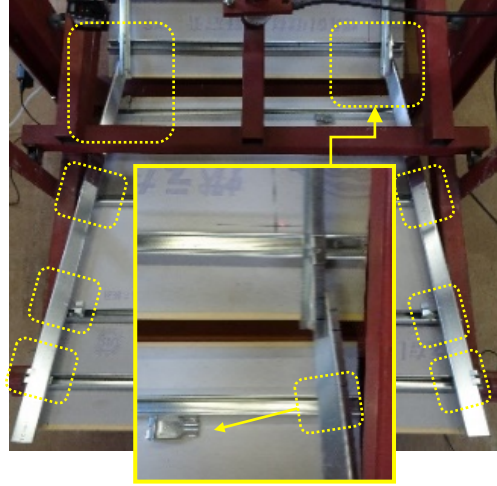
Photo 4: Clip finally disengages. (No. 6)

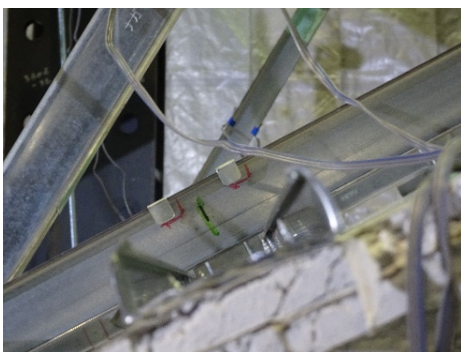
The progress of the experiment is described as follows. After the loading of about -5 mm, there was a misalignment in the clip supporting the ceiling surface which is inclined at $+30^\circ$ close to the applied position during all loading (Photo 5). The clip was joined only by friction with the C-bar in the force direction, so it seems that it was slipping with a small force. When a deviation occurred in the positive direction loading, no decrease in F was observed. On the other hand, at the time of the negative direction loading, F decreased after the deviation occurred, and the deformation proceeded. This phenomenon occurred on at the left side of the ceiling surface, but such a phenomenon was little seen at the right side of the ceiling surface. After that, when the deformation reached about 10 mm, a

Photo 6: State of $\delta = -5$ mm. The clip was slipped.

In this study, as with a general flat ceiling, it is thought that a slipping occurred because clips are not fixed with the C-bar, and hangers are not fixed, either. Therefore, when a ceiling with slope is reinforced so that they do not shift, inertial force of the ceiling surface is considered to be transmitted to the frame through the brace. Consideration of the reinforcement method based on the above is a future subject.

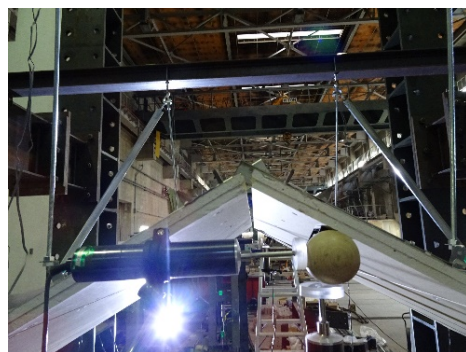
clearance was observed at the slope-changing-part of the ceiling surface (Photo 6). It means that only a ceiling surface at the left side slipped. During being damaged, no damage was observed at the slope-changing-parts of C-bar. A clip in the vicinity of the applied point opened when loading in the positive direction. Afterwards, due to loading in the negative direction, the opened clip slipped loosely on the C-bar.

Photo 7: State of $\delta = -5$ mm. Gap occurs at slope-changing-part.

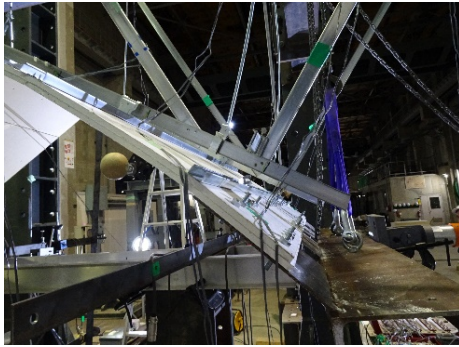
After repetition of this damage during repetitive loading, the clip in the vicinity of the applied point disengaged during monotonic loading until the end (Photo 7), bending occurred outside the ceiling surface. When monotonic loading is continuous after that, displacement of the clips of the ceiling surface progressed on the applied point side. Although F does not increase while the clip is sliding, when the displacement of the ceiling surface became large, the ceiling surface on the load applied side (left side) climbed the ceiling on the right side (Photo 8), and F increased as shown in Fig. 5.

Photo 8: Final state. Clip disengages.

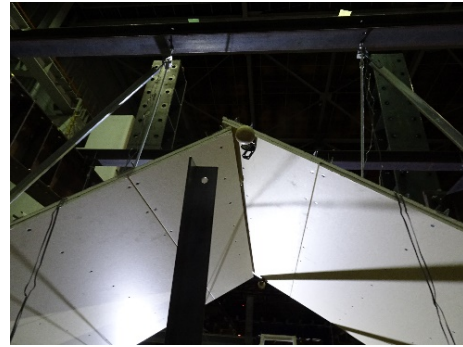
Photo 9: Final state. Contact of ceiling surface to steel furring.
