REFURBISHMENT OF AN INDUSTRIAL ESTATE INTO HOUSING COMPLEX IN BELGRADE: ECONOMIC AND ENVIRONMENTAL ASPECTS

Summary

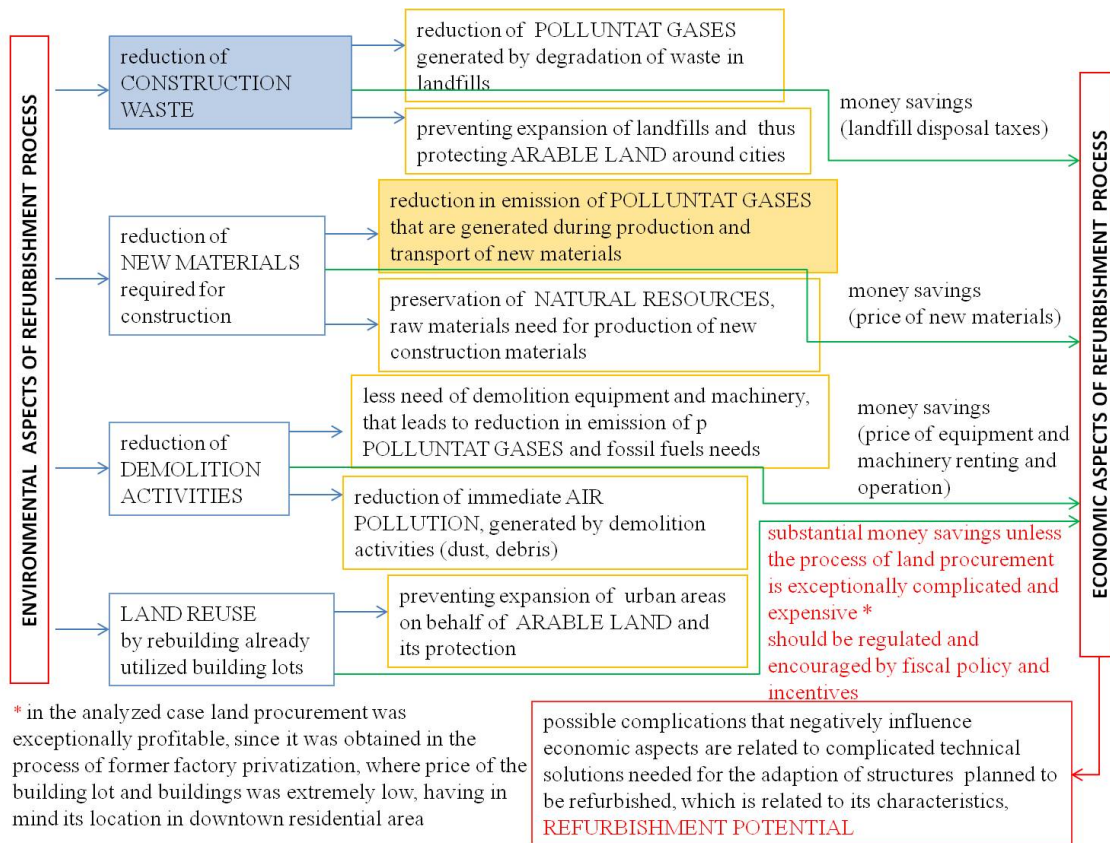
Fig. 1 Interdependences between economic and environmental aspects of refurbishment process

There are several key parameters that are regarded very favorable in environmental terms which are shown in the form of a diagram in (Fig. 1), together with their economic aspects. Capability to adapt the existing structures to new function can be defined as a *refurbishment potential*, which has the greatest impact on both of these aspects. Determination of criteria which define the quality of inherited structure is based on analysis of existing state, heritage protection measures and volume of necessary works [1].

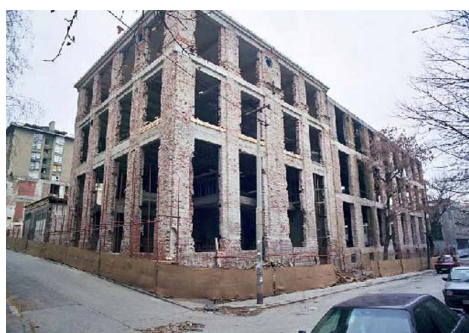
Fig. 2 Building C and D during refurbishment

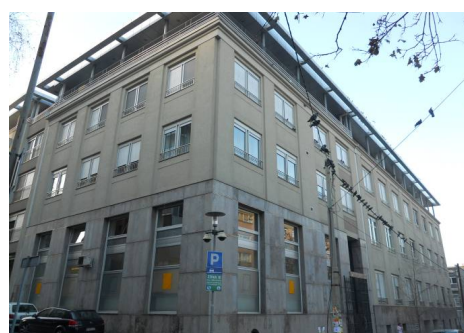
Fig. 3 Building C and D after refurbishment
