## Applicability of the Pull-Off Test: Teachings from a Large Sample of *In Situ* Tests

### ABSTRACT

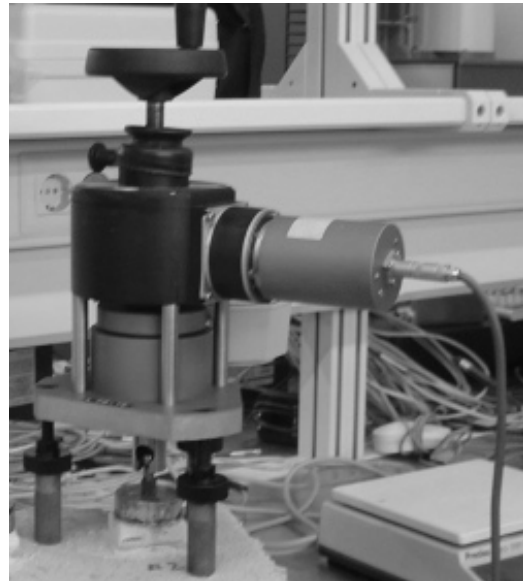
The test machine for direct pull tensile force test is in accordance with standard requirements, with the additional feature of automatic control of the applied force provided by an attached electrical engine, as presented in Fig. 1.

**Figure 1.** Pull-off test machine.

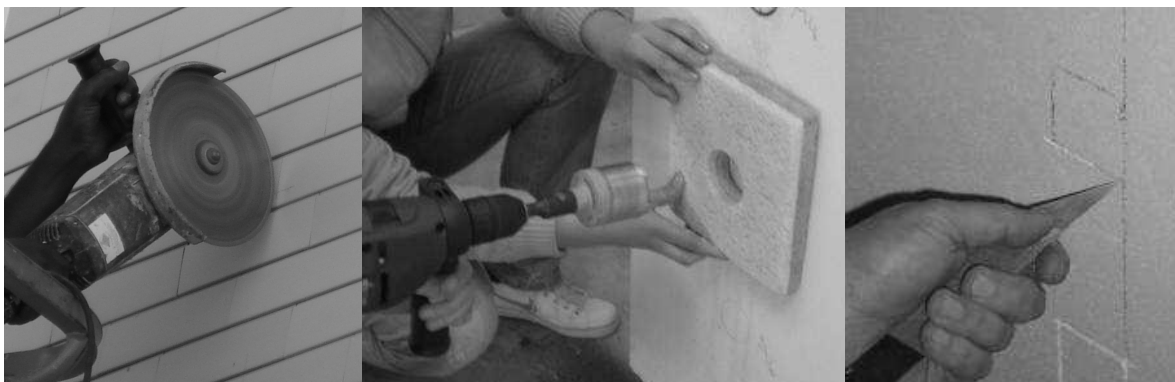
The pre-cut on the the three different systems application of the pull-off test is presented in Fig. 2.

Figure 2. Pre-cut a) ceramic tiles, b) rendering, c) ETICS

Façade cladding systems in Portuguese buildings are frequently composed of ceramic tiles bonded to substrates by means of adhesive. Adhesive bonding strength, both in tension and in shear, plays an important role on the tile bonding strength. Several standard testing methods have been established to measure and evaluate tile bonding strength (see EN 1348 [2007]). One of the difficulties of the implementation of this test in situ is to perform a low disturbance pre-cut of each specimen. Usually, square specimens are preferred, as they are easier to produce. Another aspect is where to take the pre-

cut. If it is performed deep in a render that's acting as substrate for the adhesive mortar, the failure will probably occur in the substrate, resulting in a false low result. It can however be interpreted as a performance indicator of the substrate and not of the adhesive.

Cement based renderings are also very common in Portuguese façades. The application of the pull-off test in this case is described in several standards (see EN 1015-12 [2000]). A specific analysis must be performed after the test, since a rendering can be produced in one or several layers and, therefore, interpretation is done based on the failure mode which can be cohesive inside a layer or adhesive in an interface between two layers.

Another popular application of the pull-off test is the evaluation of ETICS (External Thermal Insulation Systems) components proposed, for instance, in ETAG 004 [2000]. Again, an adequate pre-cut is essential for the test success. Since insulation is often not fixed continuously to the substrate, testing the thin rendering behaviour implies that the pre-cut must not go too deep into the insulation core.

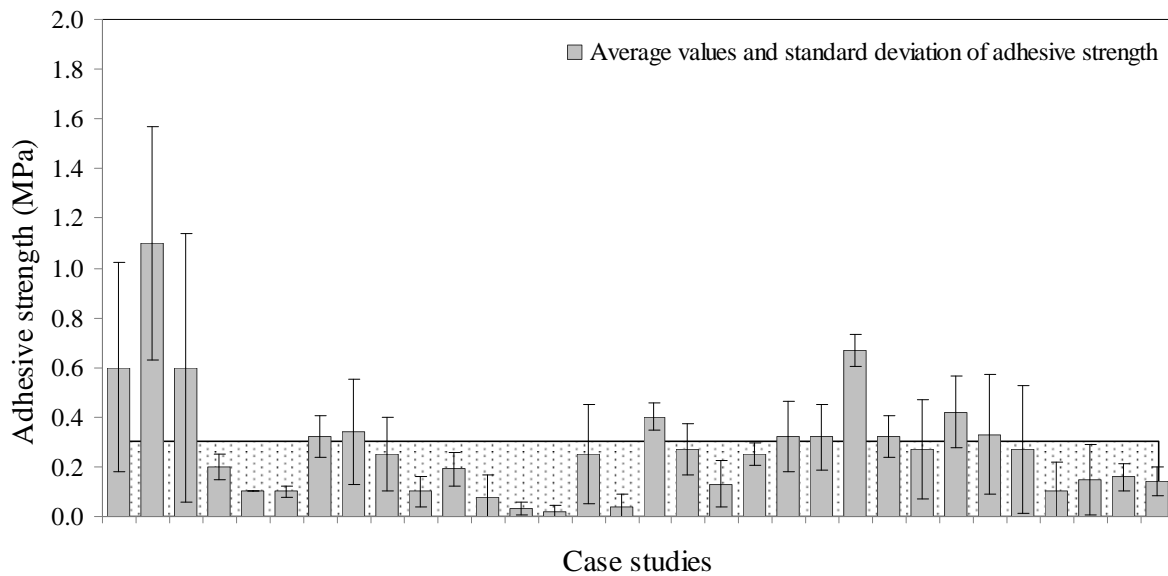
An overview of the results retrieved from the 56 case studies is presented in Figs. 3 and 4, divided between rendering and cement based adhesives. Each case study is represented by the mean value and standard deviation. The graphs also include a reference values for each material, namely 0.3 MPa for renderings and 0.5 MPa for cement based adhesives. The latter value is adopted as reference although an adequate and safe result would be above 1.0 MPa. It can be observed that the mean values for adhesive strength of renderings were typically low and frequently below the recommended value of 0.3 MPa. The tested cement based adhesives exhibited higher strength and were frequently above the reference value of 0.5 MPa and even above 1.0 MPa. On both types of tested materials, significant variations of the standard deviations could be found. The low values observed, especially for renderings, could be related to the fact that these inspections were done in façades where anomalies could be observed.

**Figure 3.** Average values and standard deviation for rendering case studies

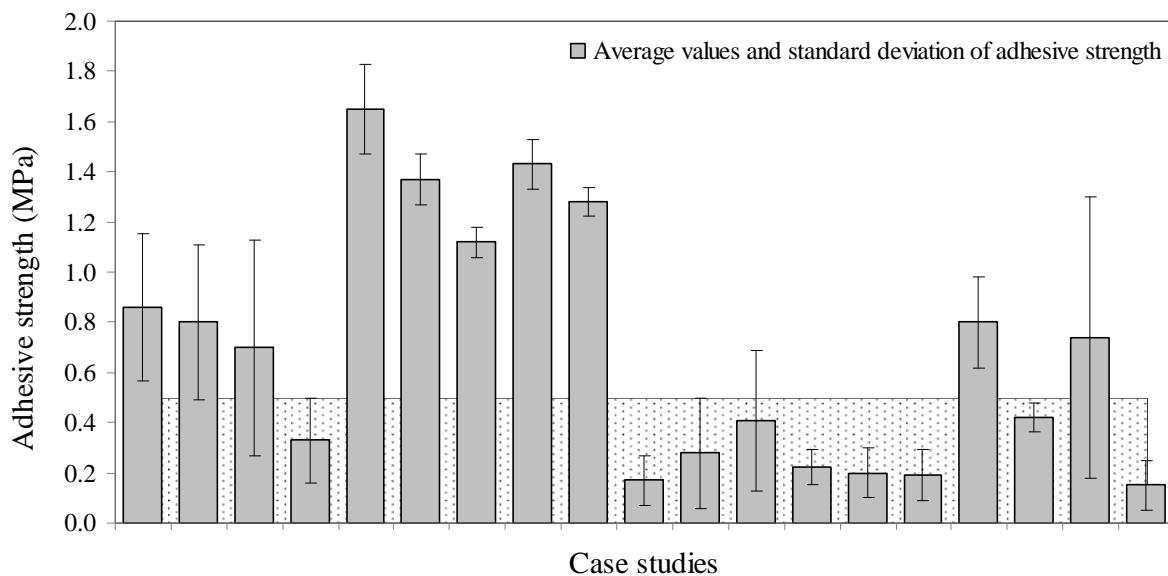
**Figure 4.** Average values and standard deviation for cement based adhesives case studies

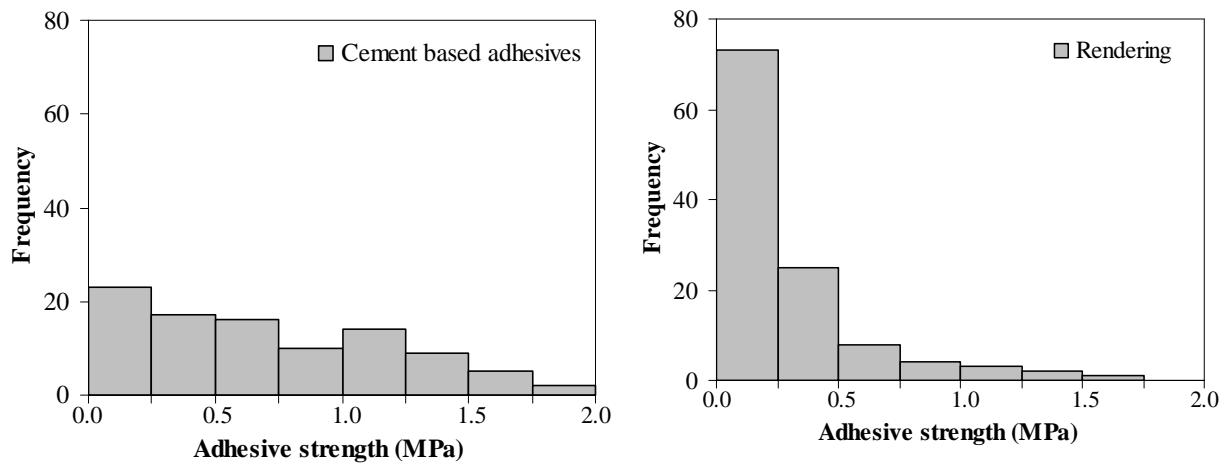
A deeper analysis of the adhesive strength found for renderings and cement based adhesives is presented in Figs. 5 and 6. The distributions found for each tested material were significantly different. While renderings presented a log-type distribution with predominant results below 0.3 MPa, cement based adhesives no theoretical model could be easily assigned. The mean was found above the reference value of 0.5 MPa. The box-plots for each material confirm this observation since, for cement based adhesives, no outliers were defined while for renderings, several values were defined as outliers, all corresponding to high resistance values.

Figure 5. Adhesion strength distribution for the tested materials

- The adhesion strength distribution found for renderings was logarithmic, presenting many values below recommended resistance while for cement based adhesives no theoretical distribution could be assigned and the mean value corresponded to an acceptable resistance;

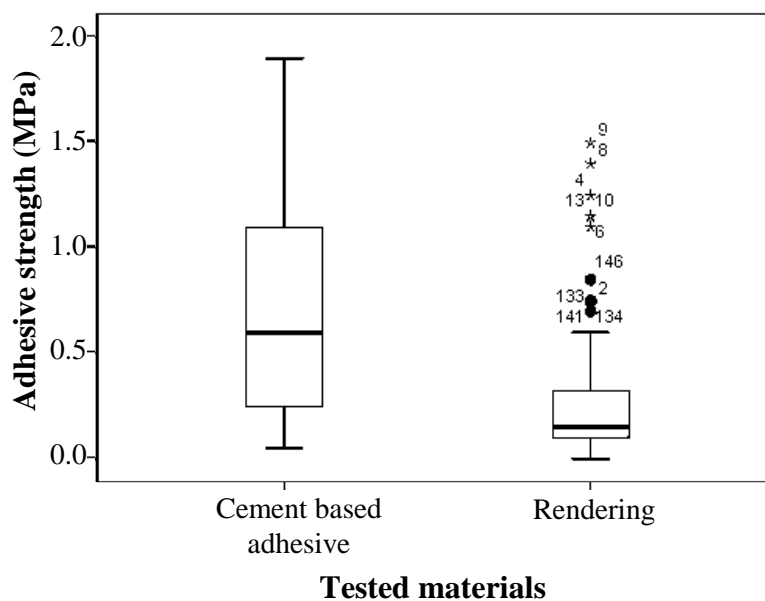
Figure 6. Adhesive strength box-plots for tested materials.

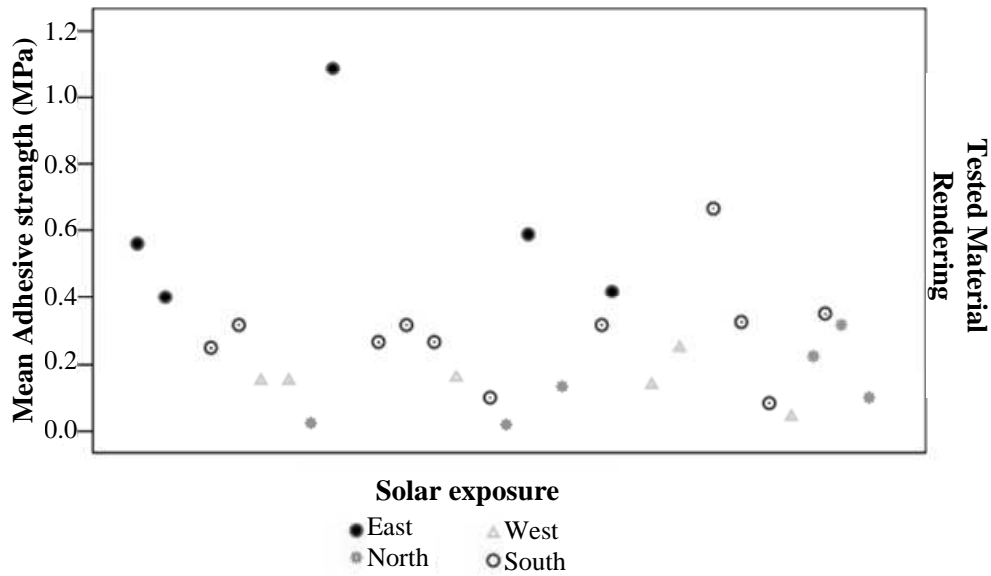
The correlation between solar exposure and mean adhesive strength was tested for renderings. The results are presented in Fig. 7. The results weren't totally conclusive but still it could be observed that the values found on the East oriented façades were higher than the ones found on South and West oriented façades. Surprisingly, the North oriented façades had the lowest values. Except for this orientation, a correlation between surface temperature in summer could almost be derived from these tests. The behaviour of the North façade may imply that other factors, such as wind driven rain or moisture accumulation would have to be taken into consideration. But for the exposure variable the

sample is quite reduced for each category implying that no actual correlations can be strongly supported.

Figure 7. Mean adhesive strength for renderings correlated to solar exposure.

- Regarding the influence of façade exposure on renderings adhesive strength, a tendency was found. But the number of cases per orientation is too low to retrieve a definitive conclusion on this subject;

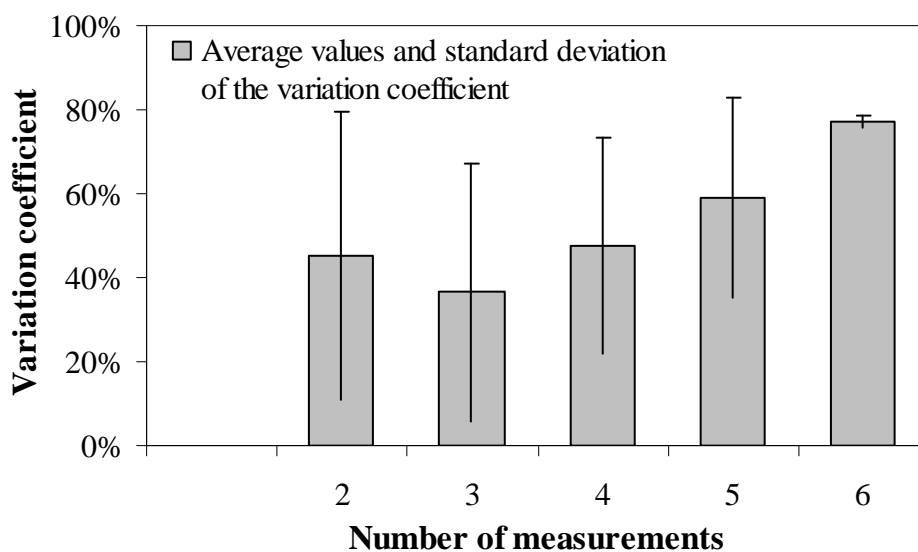
The analysis of the number of measurements influence on the variability of results is presented in Fig. 8. It can be observed that the average variation coefficient is very high and the actual variation can, in a specific test, range from almost 0 to 100%. It can also be observed that the cases where the variation coefficient was very low correspond to tests where a low number of valid pull-offs was performed. The correlation with the number of valid measurements, therefore, seems to indicate that the greater the number of valid pull-offs the greater the probability of not missing the actual variability of adhesive strength under evaluation. The eventual lack of trust in a method that results in such high variability is controlled by standards as minimum values are imposed for single valid tests and not only to the mean value. The problem of in situ tests is that often the adequate number of valid tests is not achieved due to the obvious difficulties in repeating the tests.

Figure 8. Variation coefficient correlation with the number of measurements per case study.

- The variability found in these tests was usually very high, corresponding to variation coefficients ranging from 40% to 100%.
