EXAMPLES OF SEISMIC RETROFITTING IN JAPAN

Hiroshi YAMAMOTO¹
Yasuhiro TSUNEKI²
Toshihiko KOHNO³

This paper shows some examples of seismic retrofitting designed by Nikken Sekkei. Because there are many earthquakes in Japan, buildings must not only be able to be simply repaired, but also be strengthened to resist large earthquakes so they can be used for a long time in the future. The theory and technology of earthquake-proofing is improving year by year. Here we will introduce two methods of seismic retrofitting: Seismic vibration control and Base Isolation retrofitting.

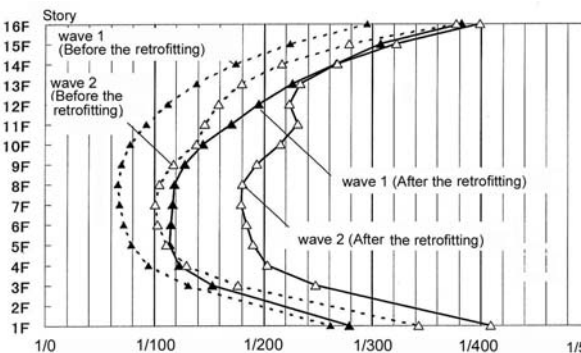
Figure 5 Maximum response story drift angle

Fig. 5 shows the responses of the building (before and after the retrofit) obtained from a time-history analysis. The target structural performance of the building, or a story drift not more than 1/100, under input earthquake ground motions at a velocity of 70 cm/s is attained. Fig. 6 shows time-history energy responses. The ratios of time-history energy absorbed by SRC frames and braces to the total energy input are 13% and 53%, respectively, indicating that the braces absorb much energy in spite of the reinforcement at a bearing capacity ratio of about 20%.

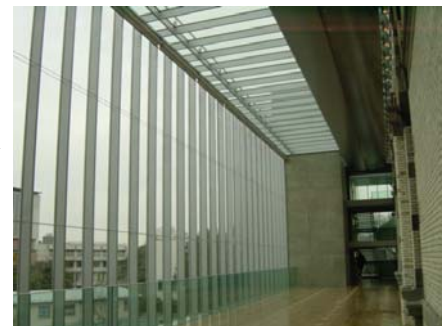
Figure 14 Steel plate column-mullion

In the expansion scheme, two steel and glass tubes are designed as if they are penetrating through the existing portion. In these tubes, 50mm thick steel plate mullions on the glass wall are braced by high strength rods and support floors and atriums. Most of the mullions are made of fire resisting steel without fireproofing. Pretension introduced to the high strength rods was high enough not to turn to compression with heat expansion in the case of fire (See Fig. 14).
