USED BUILDING MATERIALS FOR LOW-COST CONSTRUCTION*

ABSTRACT

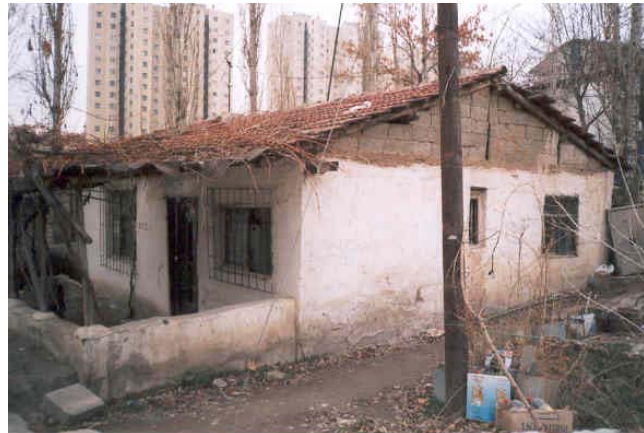
Figure 1. A squatter house in Ankara, built with salvaged material, mismatched windows and iron grills.

2.2.1 Low-Cost Housing. Squatter settlements are thickly populated densely built areas. Unlike their counterparts in Asia or Africa, squatter houses in Turkey are permanent structures built of brick and mortar, the roof is made of timber protected with clay tiles and they have electricity and water connections, which are sometimes illegally obtained. Lack of security is manifest in the presence of iron grills in the windows of all buildings, to keep out potential intruders (Figure 1).

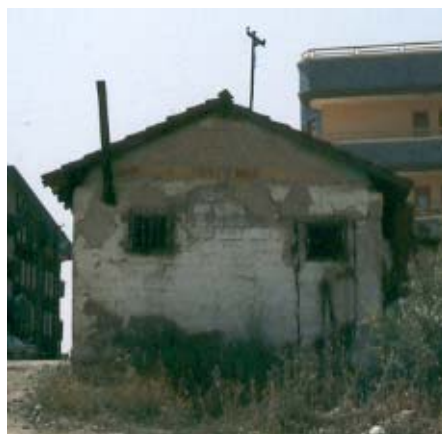
Figure 2. A squatter house in Ankara, built with salvaged concrete blocks that still have bits of old plaster and paint sticking on them.

- The structures were usually one or two storeys high, built with load bearing brick or concrete block masonry, mostly plastered and painted. Sometimes walls were made of used concrete blocks that still carried traces of old plaster and paint (Figure 2). Buildings with more than two storeys had a reinforced concrete column and beam structure; such buildings were usually located in informal settlements of past which have now been granted land tenure.

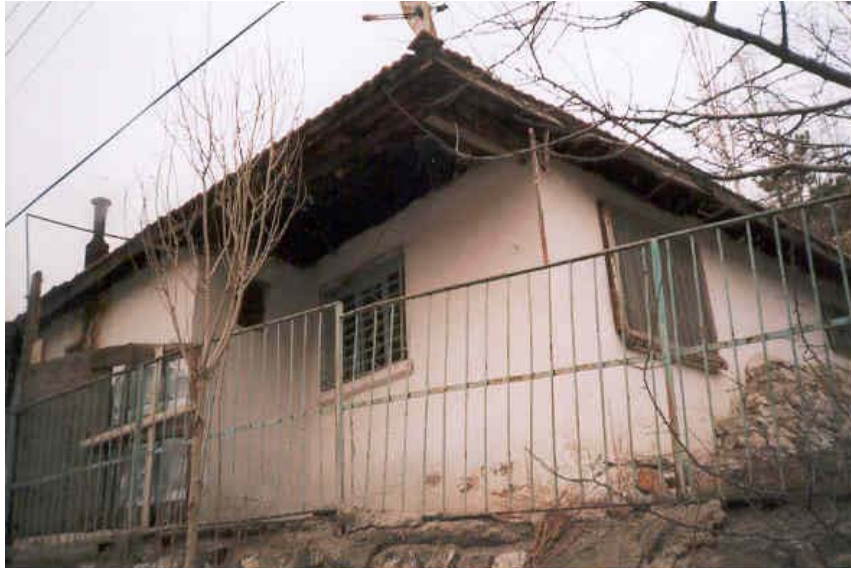
Figure 3. A squatter house in Ankara: the iron-grills are rotated to fit the windows.

- Protective iron grills over the openings varied in sizes and designs and, generally, did not fit properly. It was also possible to see that when a set of matching grills, that were obtained from the DCY, did not fit all the windows because the windows themselves were not of a standard size, some were rotated to cover the openings as best as they could (Figure 3)

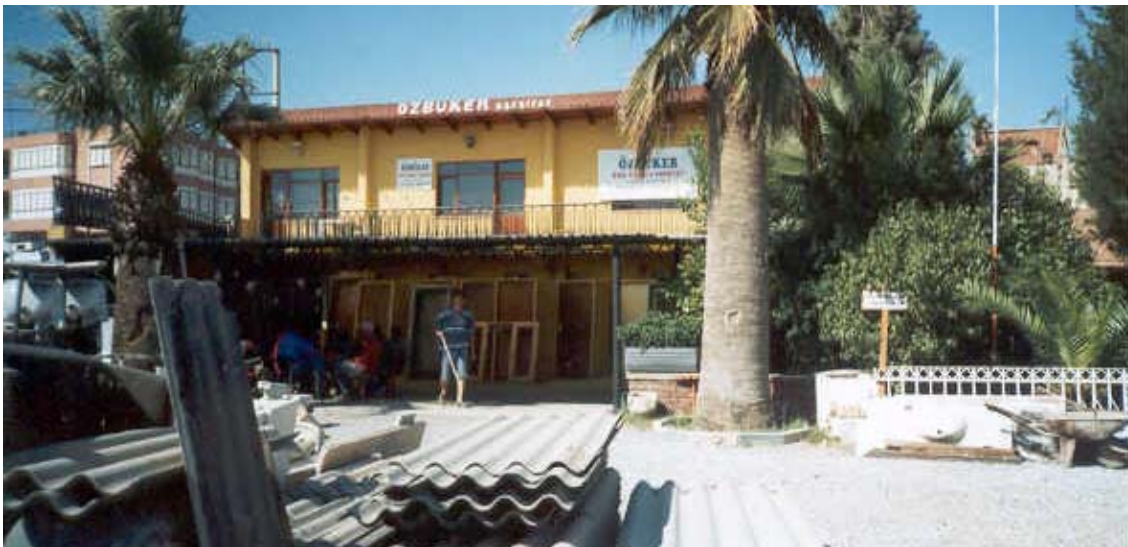
Figure 4. Front view of the double storied office building in the demolition contractor's yard in Buca.

2.2.2 Case Study in Buca. The case study was conducted on a small office building, which belongs to a leading demolition contractor of Izmir and is part of the facilities present at the contractor's yard in Buca, near Izmir. All the three buildings, two workshops and the three sheds at the yard were built from UBM that the owners had salvaged from demolition and renovation projects. The small double storied office building, which was the most recent addition, was surveyed in detail and as can be seen from Figure 4 below, it did not lack in quality or style just because it was a low-cost construction using salvaged material. Although no records were kept about the amount or type of UBM used for the construction, their cost and the number of worker employed, an educated guess could be made from the measured building. The concrete and masonry work was done by hired labour but the carpenters in the employ of the contractor did the finishing work.

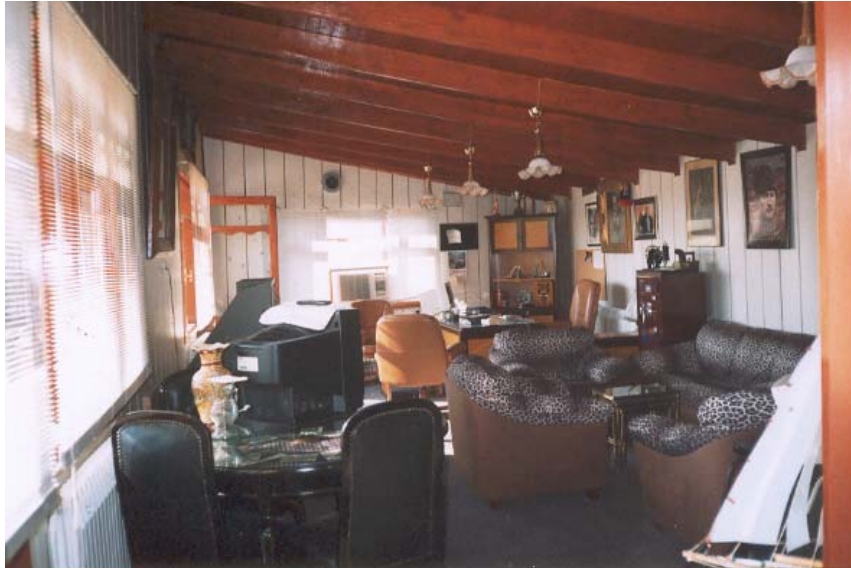
Figure 6. Interior view of the office building at the demolition contractor's yard in Buca.

The building has a reinforced concrete column and beam structure and masonry walls on the ground floor while the upper floor was built with load-bearing masonry walls. The sloping roof is constructed of timber joists and planks covered with layers of water- and heat- proofing and protected with clay roofing tiles. All doors and windows on the ground floor are made of aluminium painted with white enamel but those on the upper floor are made of solid wood, finished off with clear varnish. The walls are plastered and painted, except on the interior of the large office room, which has off-white "Sunkalam" (laminated fibre board) panelling. All the building material, including the timber components, bathroom tiles, fenestration and carpet are salvaged materials; even accessories like lamps and bathroom fittings were old; only the Sunkalam panels, concrete and paint was new. Interior views of the office and bathroom on the first floor can be seen in Figures 6 and 7 below.

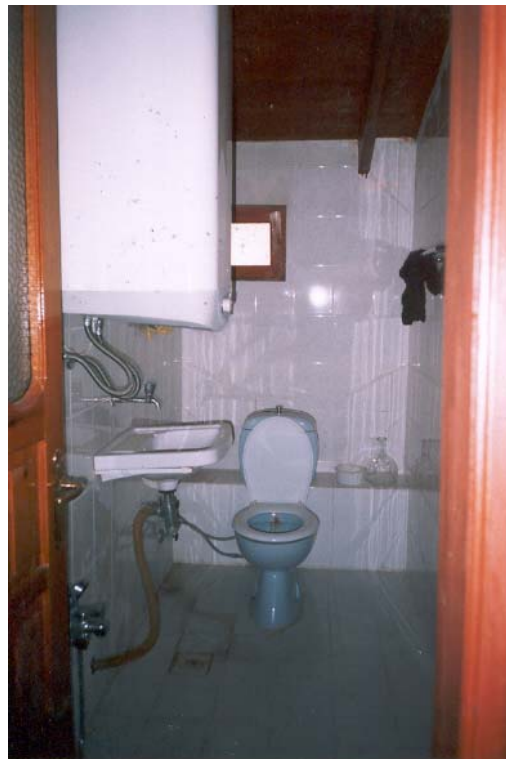
Figure 7. Interior view of the toilet in the office buildings in Buca.

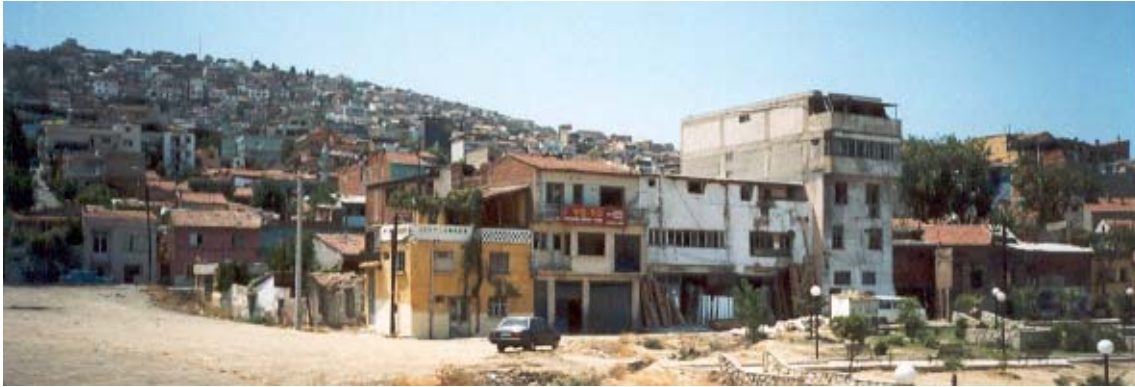
Figure 8. Low cost buildings showing evidence of incremental construction, with squatter housing in the background, in Izmir.

the need arose, or when there were enough funds to meet the cost of additional space. Whether the buildings consisted of one storey or more, it was possible to observe the different stages of construction from their exteriors, as they presented a haphazard configuration of elevations as well as a potpourri of styles, shapes, sizes, material and quality. Moreover, the locations of openings at all floors appear to be at random, which is an indication of an organic expansion of the building (Figure 8).

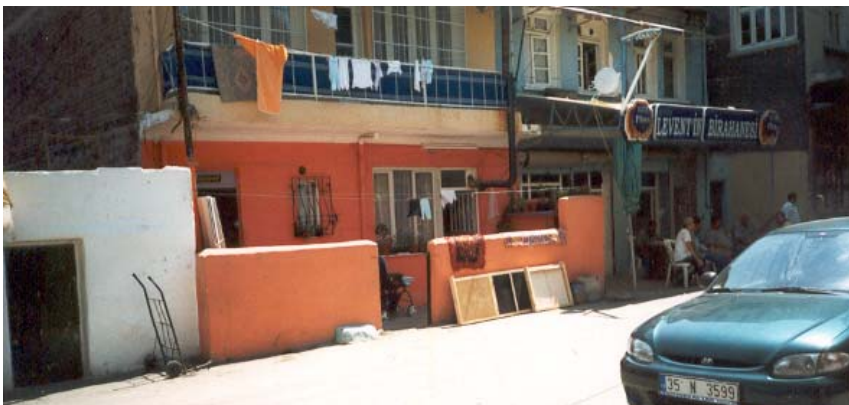
Figure 9. Low-cost buildings in Izmir, built with used building components.

It was also apparent that buildings were constructed not according to a pre-determined plan or design, but in abeyance to the constraints set by the types and sizes of UBM the owners could afford to buy. The reason that the parapet or lintel heights were not consistent and the openings did not align horizontally or vertically was probably that matching fenestration could not be found at the DCY. By and large, utility and affordability took precedence over aesthetics or even comfort in squatter housing. However, in some low-cost housing examples in Izmir, a concern for visual harmony was witnessed (Figure 9).
