The Kasumigaseki Building's Planning and Technology: Japan's First Skyscraper from the Viewpoint of Renewal

Ryohei KUMAGAI,
Tokyo University of Science, Tokyo, Japan
(email: kumagai@rs.kagu.tus.ac.jp)

The Kasumigaseki Building is Japan's first large-scale skyscraper, and it has undergone three renewals in total. This study analyzes the previous renewal works done on the building, and it aims to obtain knowledge that can be utilized in the maintenance of skyscrapers in the future. One of the characteristics of the Kasumigaseki Building renovation work was that it didn't need major earthquake-resistant reinforcements. In addition, the extra space that was left in the floors that held the air conditioning equipment was effective for the renewal. Moreover, the existing honeycomb beams allowed pipes to be easily installed above the ceilings when making major updates to the air conditioning systems. Another benefit was "the lateral plumbing unit" that was developed for the toilets in the Kasumigaseki Building. It eliminates the need for piping to be run down to the lower floors because the piping is positioned above floor level.

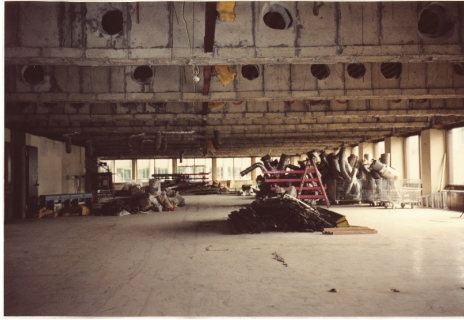
Figure 5. Office floor during construction. (Mitsui Fudosan archive)

With respect to the office space, interior finishes such as the floors and ceilings were fully renewed with upgraded products (Figure 5, 6). Since the original ceiling used a 3.2 m modular line type system still in use today, the new system ceiling basically used the same system. The floor finish was upgraded from the original PVC carpet to the tile carpet that is now popular. The ceiling height (2,640 mm) remained unchanged even after installing OA floor system, as the original construction had allowed extra space above the ceiling that accommodated the floor's increase of 80 mm. The depth dimension of the window perimeter was deep since the induction units of the air conditioning had been built along the window, but the space under the window expanded by 160 mm and occupants' comfort was improved by the removal of the induction unit with the renewal of the air conditioning system (Figure 7). The necessary construction period per floor was about 4 months, and it was requested that the construction must be completed within a fixed construction period of 16 weeks per floor to avoid compromising the tenants' relocation schedule. (Mitsui Fudosan, 1994)

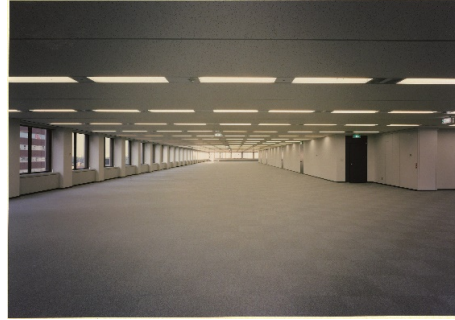
Figure 6. Office floor after the renewal. (Mitsui Fudosan archive)

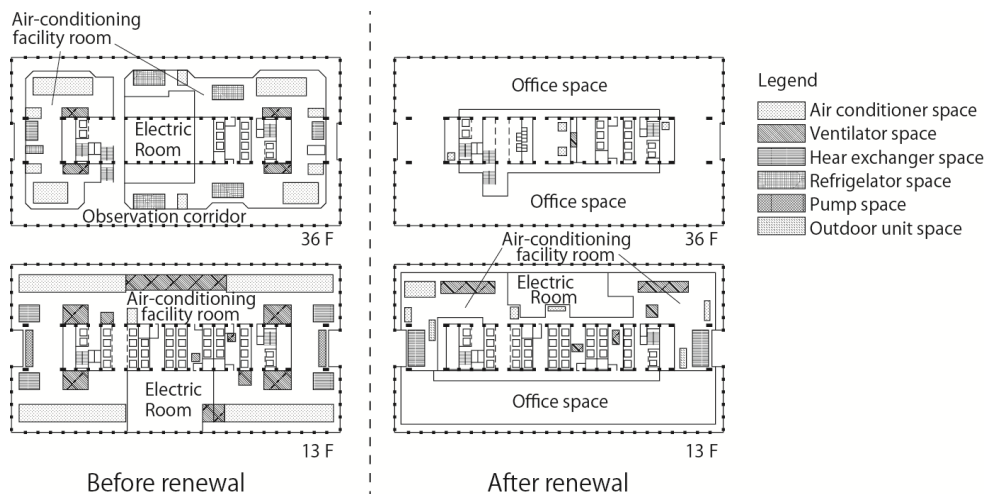
Figure 8. Changes before and after the renewal of air-conditioning facility rooms. (Mitsui Fudosan, 1994)

For the renewal of special floors, layout changes were made on the 36th floor and the 13th floor, which held equipment facility rooms (Figure 8). As requirements for the air-conditioning equipment

room were sharply reduced by the new floor-specific air conditioning upgrade, half of the space on the 13th floor was developed as a new office. The 36th floor, used as a provisional relocation office at the time of tenant relocation work, became a general office space after the renewal. The common spaces on each floor, interior finishing of the corridors, and the elevator lobbies were redesigned (Figure 9); additionally, the elevator was updated to a group-management system with learning function. The interiors of the toilets were refurbished and converted to restrooms, and the sanitary equipment was also updated to the latest technology, including the piping unit. (Mitsui Fudosan, 1994)

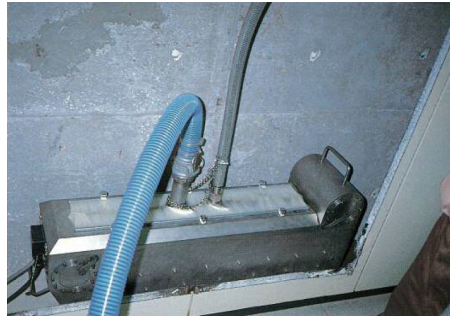
Figure 12. Opening work by rotary water jet method. (Mitsui Fudosan, 1989-1994)

Continuing office operations during renovation makes it necessary to minimize noise, vibration, and dust. Drilling work for the facilities was carried out following the establishment of the electric trunk line, but thanks to a research and development carried out by Kajima Corporation before the renewal construction of the Kasumigaseki Building, a rotary water jet construction method was applied that could crush only concrete, leaving existing rebar, conduit, etc., in place, which reduced problems with noise and vibration (Figure 12). (Mitsui Fudosan, 1994)

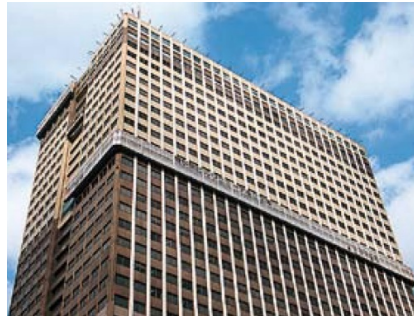
Figure 14. Exterior wall painting with full-circumference scaffolding. (Mitsui Fudosan, 1999-2015)

restore the original appearance and coloring of aluminum finish, but fluoropolymer paint used to improve weather resistance. Trial painting was carried out on the actual curtain wall, and stakeholders familiar with the building's appearance helped select the color closest to the original. To ensure quality and shorten the renovation period, the exterior painting was carried out using temporary scaffolding encircling the entire circumference (Figure 14). (Mitsui Fudosan, 1999-2015)

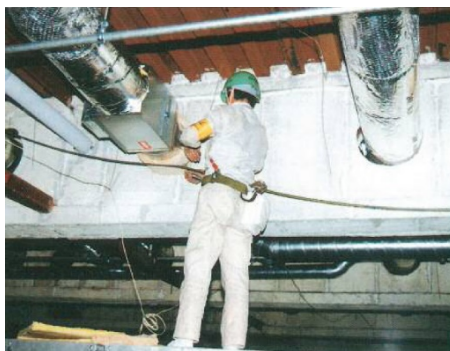
Figure 16. Air conditioning update work using existing sleeve.
(Mitsui Fudosan, 1989-1994)

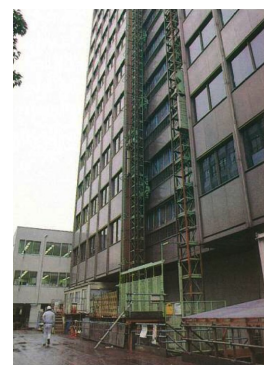
Figure 17. Carry-in utility lift.
(Mitsui Fudosan, 1989-1994)

Renewal of the Kasumigaseki Building did not address the building's large earthquake-resistant reinforcement since it was originally designed to be as safe as possible based on dynamic computer analysis at the time of construction. On the other hand, as the facility equipment were renewed numerous times, it was effective for renewal that the air conditioning machine room was originally designed with a space margin. Moreover, in order to make major updates such as the air conditioning system, the existing honeycomb beams worked favorably for the installation of piping behind the ceiling (Figure 16). The “sideways drain piping unit” of the toilet, developed for the Kasumigaseki Building, had the benefit of eliminating the need for construction on the lower floor because the drain pipe did not penetrate the floor slab. A carry-in lift had been installed in the balcony at the center of the short façade. This was for disaster evacuation and to protect the façade design, but it also assisted significantly in lifting materials and equipment during renewal (Figure 17).
