EVALUATION AND COMPARISON OF POST-DISASTER HOUSING IN TURKEY; LESSONS FROM IKITELLI AND SENIRKENT

A. T. Özden

Department of Architecture, Middle East Technical University, İnönü Bulvarı – Ankara, 06531, Turkey

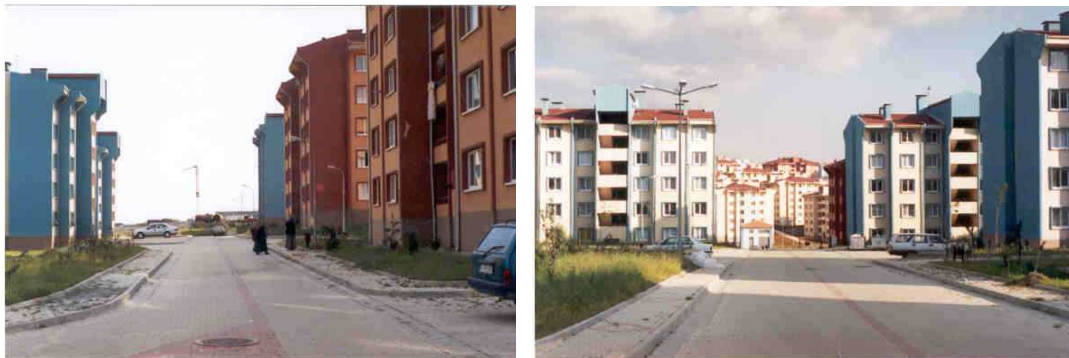
Figure 1: Scenes from Ikitelli Post-disaster Housing settlement

Ikitelli district, which is located on European Side of Istanbul, is one of the selected districts for application of post-disaster housing project. In June 2000, the construction started under the control of The Ministry of Public Works and Settlement. The project was composed of 810 dwellings (Figure 1). Both the project and the construction were entrusted to the contractor firms by The Ministry of Public Works and Settlement. The selected firms - UBM, Yavuzlar, Uralsan - finished the first 650 dwellings in September 2001; and the rest, 160 dwellings, were finished at the end of year 2002 (Özden et al, 2003).

The uncompleted infrastructure (road and streets, natural-gas lines, telephone etc.), low construction quality of houses and difficult transportation problems were the primary problems which the households complained. It was observed that some households preferred to come and settle in their new houses very late because of such problems. The delay in settling also had been causing the delay in adaptation to new environment of the victims (Özden et al, 2003).

The construction problems of post-disaster housing; water installation systems (especially bathroom installations) were causing some serious problems almost in every dwelling. The exterior walls, facades were not water-resistant (rain, snow etc.) and there was always water leakage from exterior walls of the dwellings. The building materials were of low quality (installations, windows, doors, paintings etc.). Water leakage and humidity were some of the problems faced in basement floors.

The design problems of post-disaster housing; some of the buildings were constructed without basement floors. On the other hand, after the 1999 earthquakes, the building codes and legislations were changed and the basement floors had become a must in new buildings. So, Ikitelli Municipality authorities did not give building inhabiting licence yet at the time of the study to those buildings according to new building codes. Heating systems of the buildings were planned according to natural-gas heaters, unfortunately natural-gas infrastructure (pipe lines) had not been constructed to the area yet. So households could not use this system. They had to establish a traditional-old system, stoves in which wood and coal were burned. However, there were not adequate numbers of chimneys designed in the dwellings.

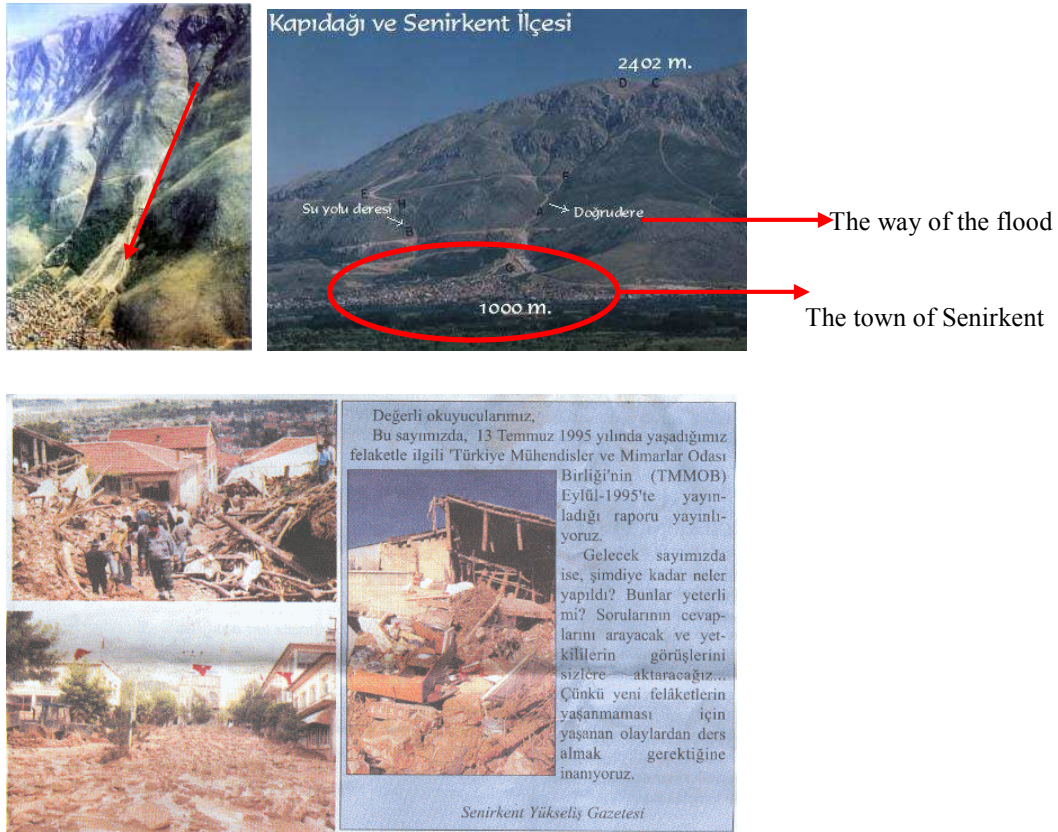
Figure 2: Scenes from Senirkent Flood Disaster

On 13th of July, 1995, soon after a heavy rain at the evening hours, a huge and destructive mud flood destroyed a total number of 320 dwellings, of which 195 were completely destroyed, 18 moderately destroyed, and 107 lightly destroyed. The disaster

killed 74 people and injured 46 people (Figure 2). Dwellings that were constructed with mud-brick could not resist to the flood, also called as *cold lava* by the authorities (Özden, 2004).

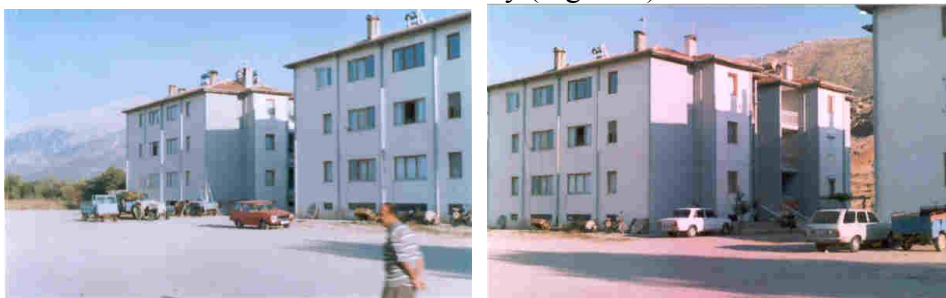
Figure 3: Scenes from Senirkent Post-disaster Housing settlement

Soon after the disaster, The Ministry of Public Works and Settlement started to look for an area for constructing post-disaster housing. The main criterion was its flatness and being far from the flood area for choosing the area. The methodology and approach for post-disaster housing project and construction were the same as in Ikitelli example. The ministry entrusted and gave the job to a firm for construction. In fact the projects had been designed for another post-disaster housing area previously, so the revision and application to the new area would not take the authorities of the ministry too long. They could finish the projects nearly in 10 or 15 days, and send to the contractor firm. The construction started in August 1995 and finished in December 1995. 188 dwellings were constructed which were composed of 16 blocks, 15 of which were three-storey blocks and one of which was two-storey (Figure 3).

- The projects were designed without meeting the residents' social, economical, and cultural needs,
- During the design and construction period, the users' thoughts were not taken into consideration by the authorities,

- The decision in the place (area) preferences was thought to be completely wrong, the useful and productive agricultural areas were used in building apartment blocks,

- The infrastructure was very weak and insufficient,
- The quality of construction and building materials was very low,
- The post-disaster settlement was far away to the town centre so this caused difficulties in reaching the town centre and bazaar of the town, especially for disabled people, and elderly people,

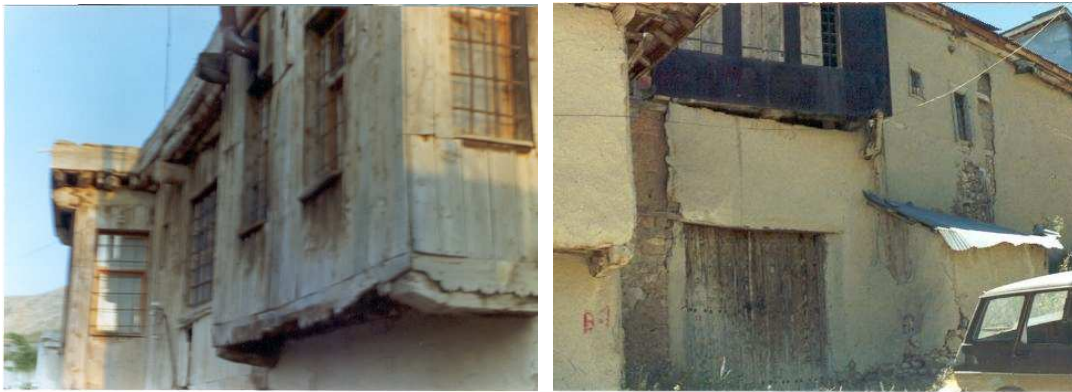
Figure 4: The traditional adobe houses of Senirkent

Ikitelli district is located in the metropolis of Istanbul, which is the commercial and industrial centre of Turkey. The life standards, habits, economic life of the people of the region were crucially different from the residents' who were living in a town such as Senirkent. Ikitelli post-disaster housing households had been used to living in apartment blocks for a long time; on the other hand, victims of Senirkent flood disaster had been living in independent-adobe houses for nearly 200 years (Figure 4).
